ASH CREEK ESTUARY

Master Plan 2023

Ash Creek Conservation Association, Inc.

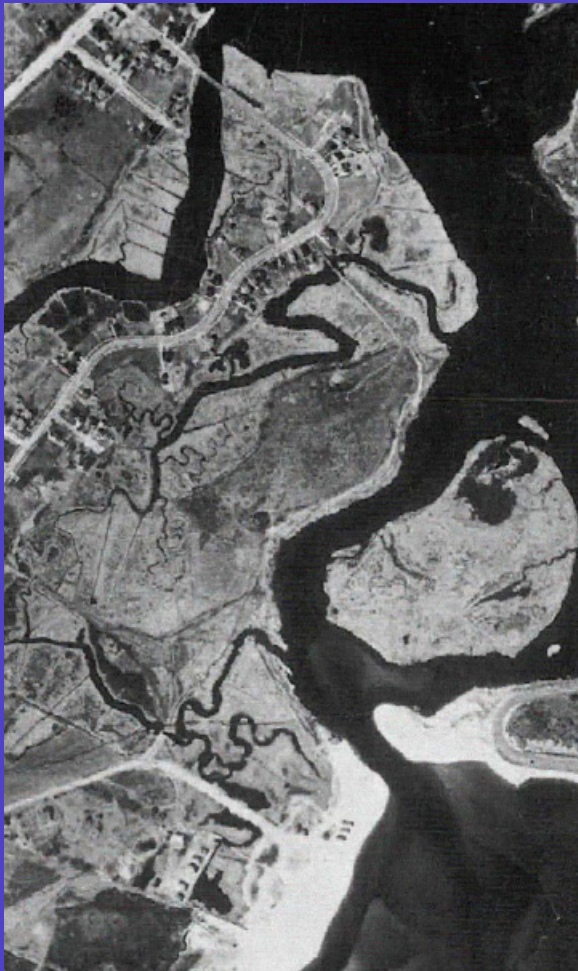
1934

South Benson Marina is a relatively new addition to the Estuary. It was created in the post-WWII population boom of the 1950's along-side rapid residential development in Fairfield County. In recent times, the navigable channel required for the Marina has been deepened to allow for larger and deeper drafting boats. Because in sandy coastal environments deeper channels require wider slopes, the Barrier Spit appears to suffer even more rapid decline in recent years.

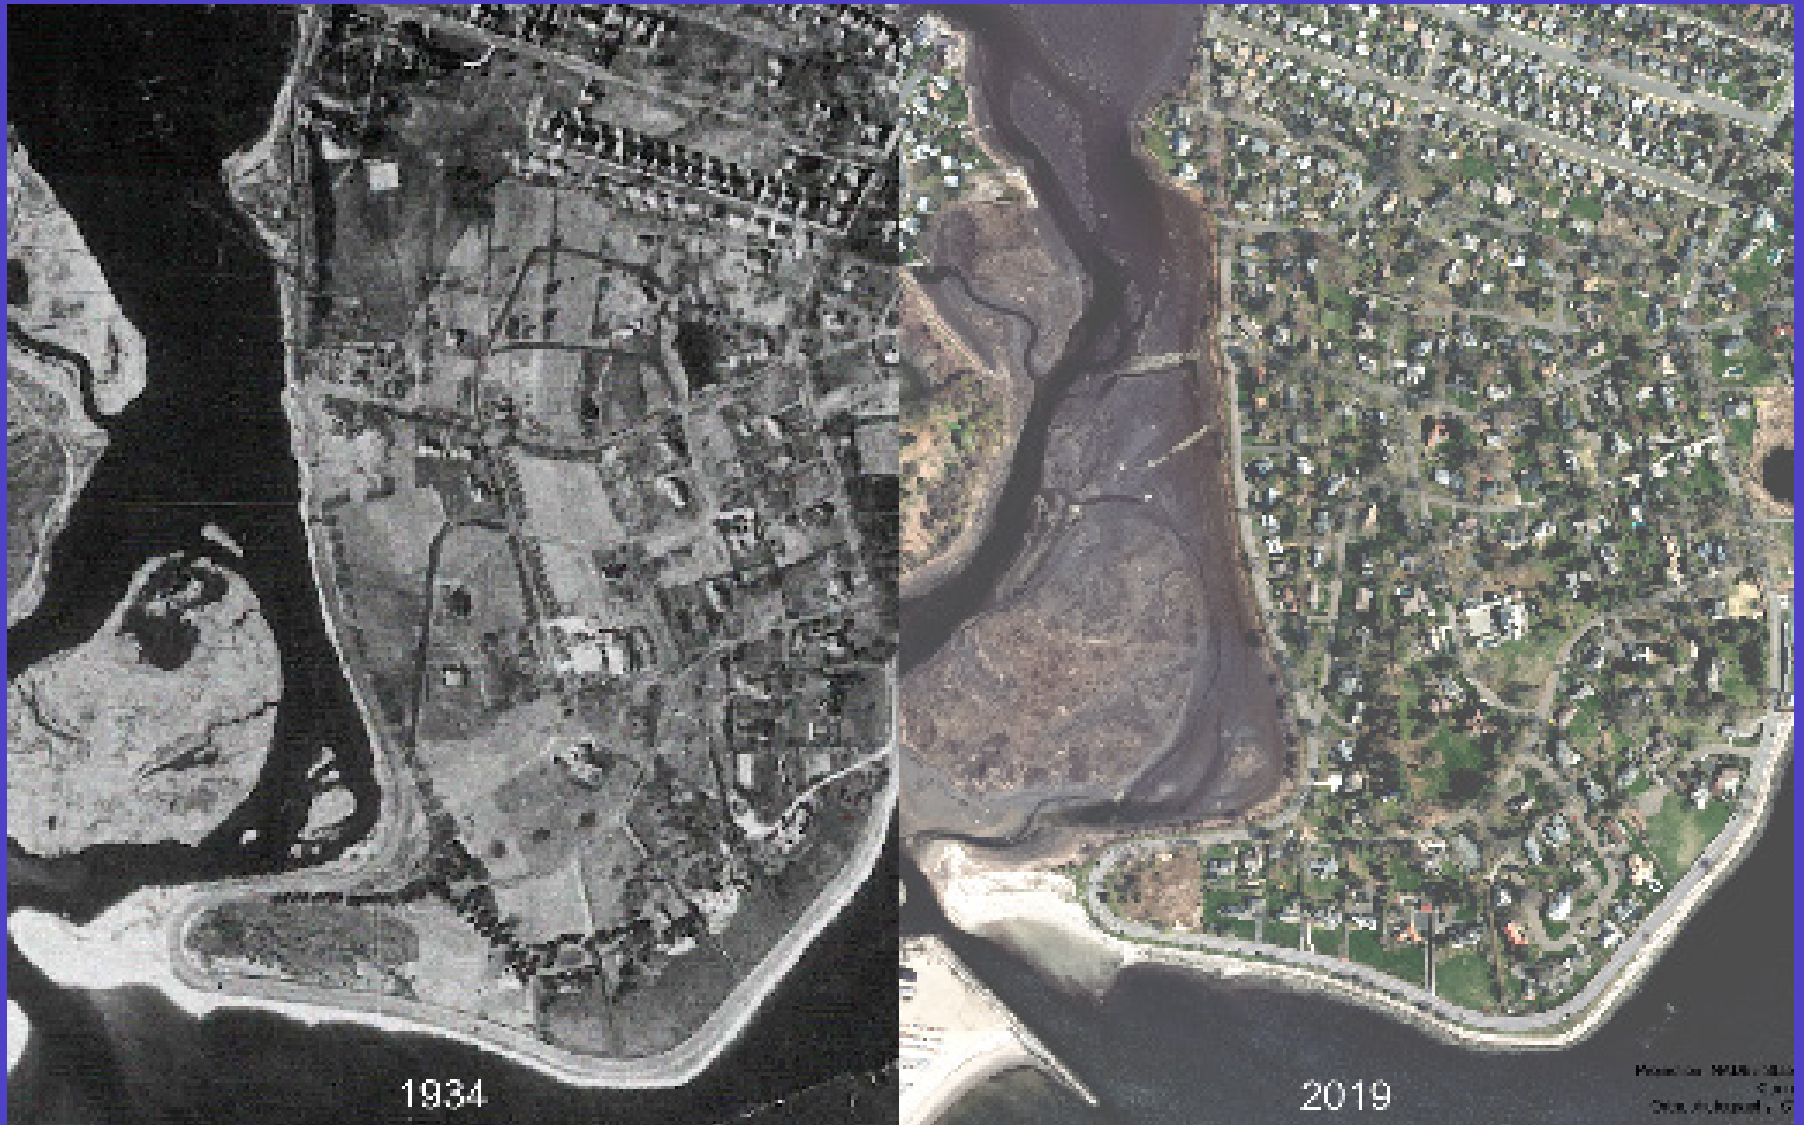
This comparative aerial analysis of the Black Rock neighborhood shows the extent of fragmentation that has occurred in the past 90 years.

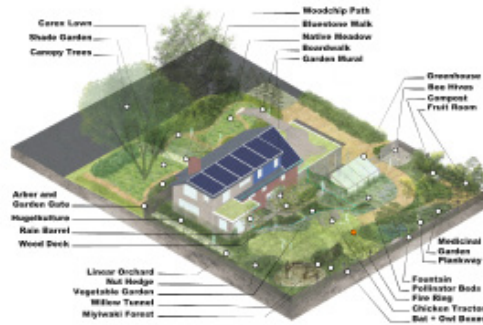
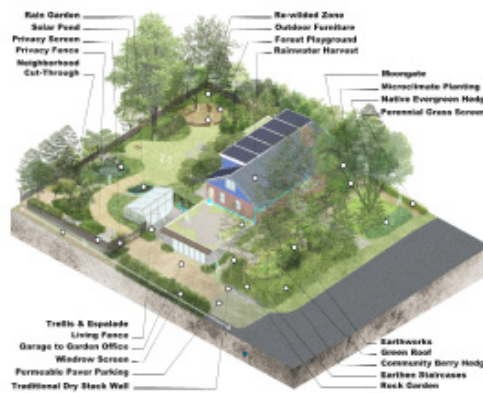
The two images on the right illustrate how much potential exists in low-density and suburban areas to make major ecological improvements. While most landowners do not have the resources to build a landscape as intensive as this one, most can incorporate at least a few of the technologies shown here.

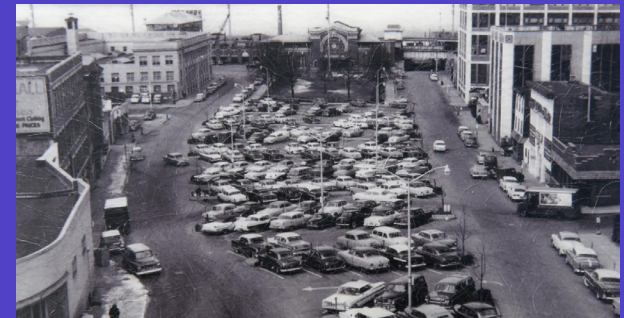
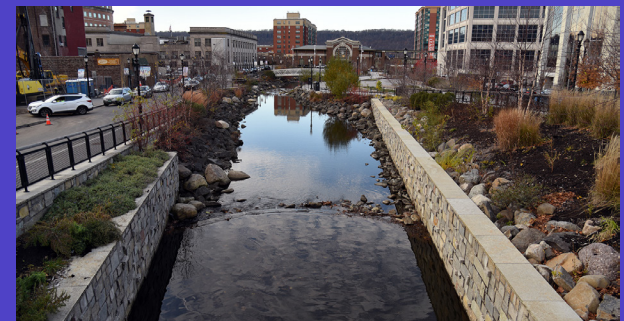
Saw Mill River, Yonkers, NY

The Saw Mill River in Yonkers, NY was once covered by concrete deck but has been “daylit” and restored with native plants and boulders.

“Stream Daylighting” is the practice of uncovering buried watercourses for ecological restoration purposes. Many small perennial and intermittent streams that once flowed in the Estuary have been buried by sewer systems. This centuries old practice has resulted in “pinch points” for rainwater during floods while dramatically reducing habitat connectivity. Where possible, streams should be “daylighted.”

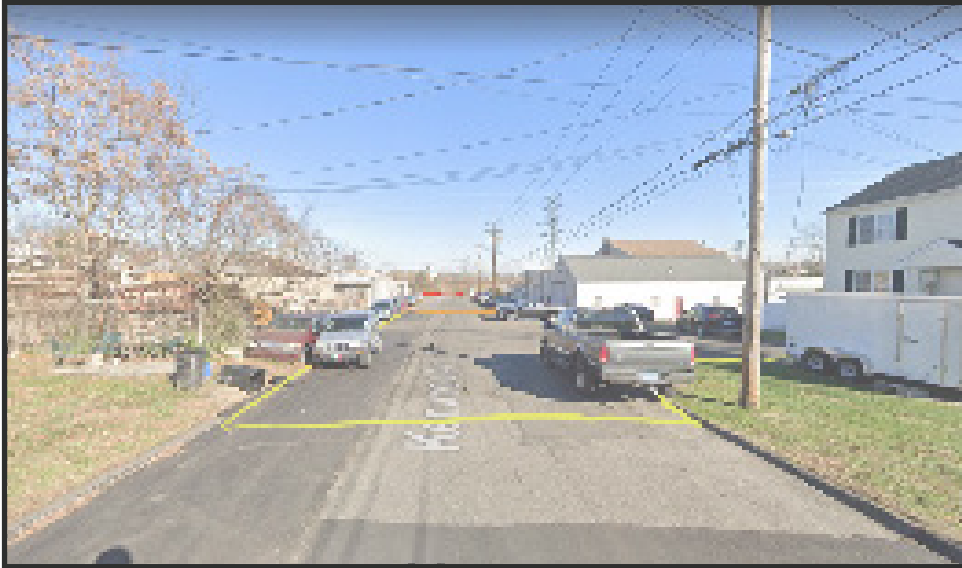
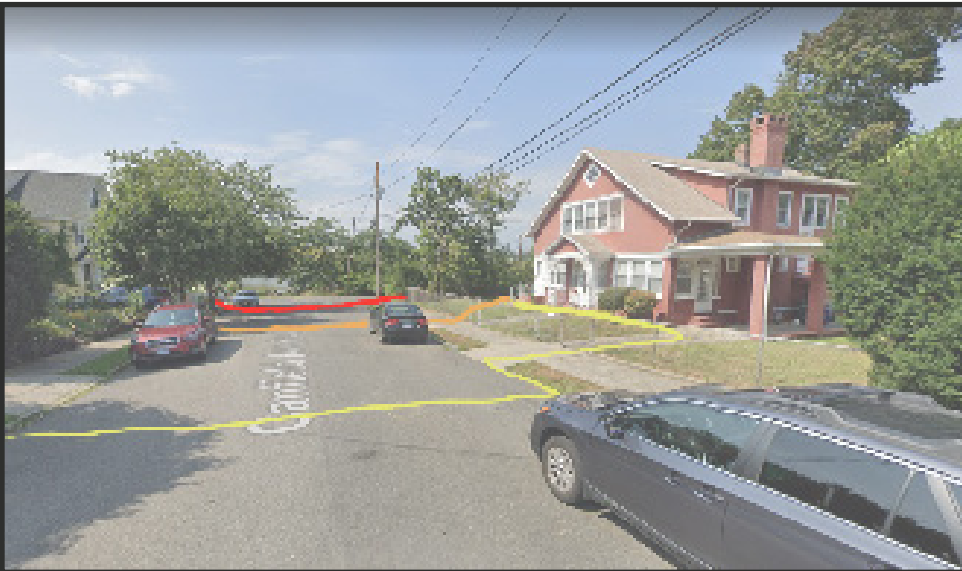
- 2 ft Sea Level Rise - Low
- 4 ft Sea Level Rise - Intermediate
- 6 ft Sea Level Rise - Extreme

Sea Level Rise. The following areas are likely to be most impacted by sea level rise in this study area:

- The intersection of Kenwood and Kenard
- Canfield Avenue
- Davidson Street End
- The MetroNorth Railroad line is likely to be systemically impacted along it's length. It is unknown how ridership and services will be impacted.

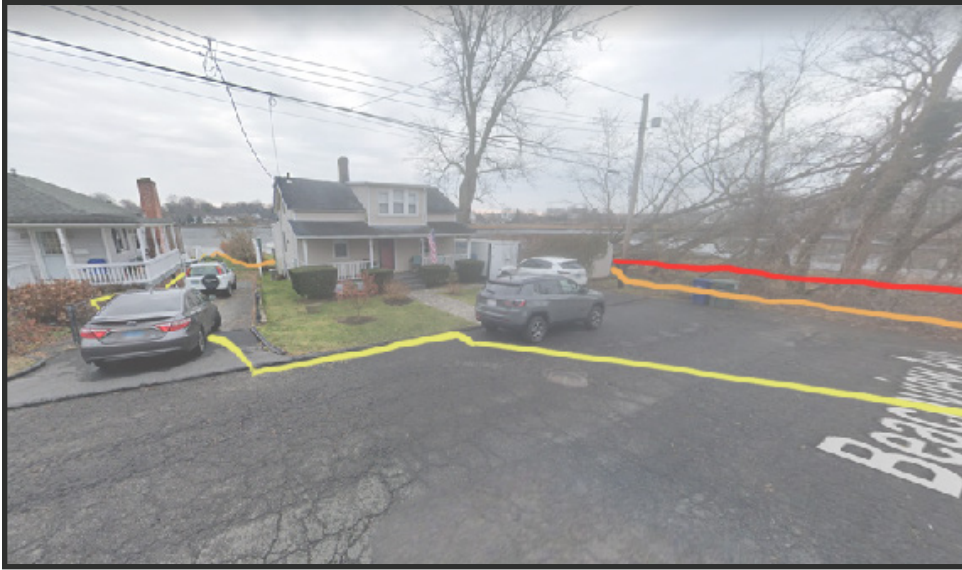
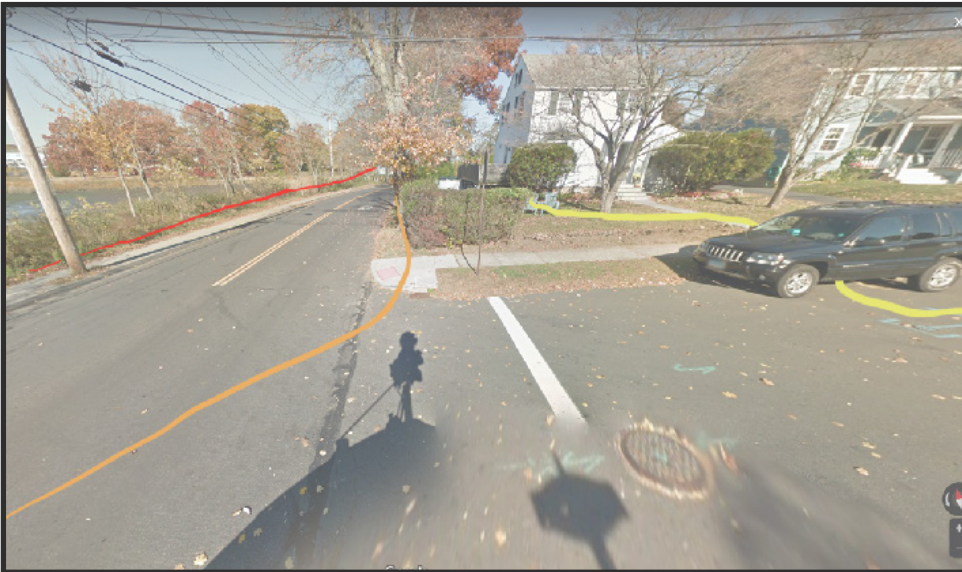
- 2 ft Sea Level Rise - Low
- 4 ft Sea Level Rise - Intermediate
- 6 ft Sea Level Rise - Extreme

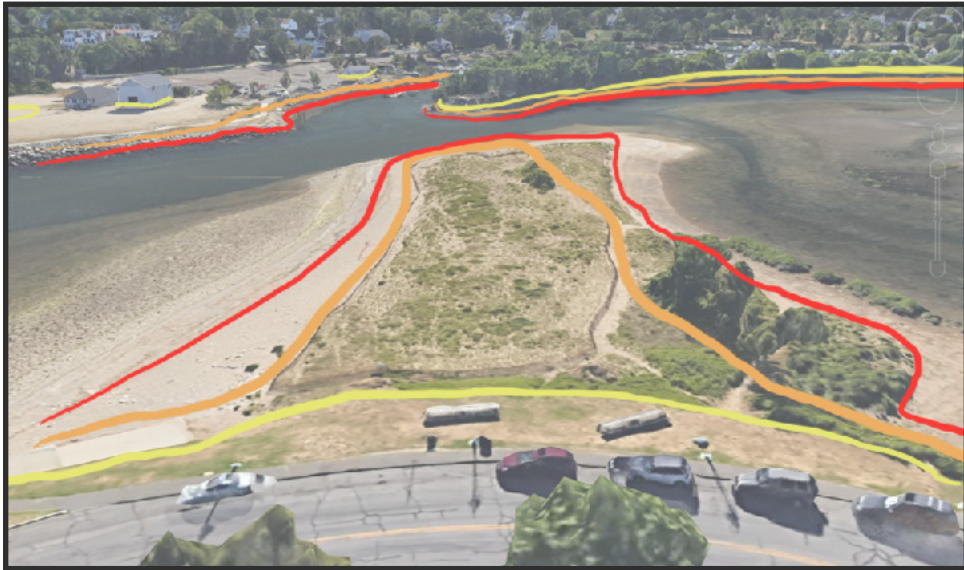
- 2 ft Sea Level Rise - Low
- 4 ft Sea Level Rise - Intermediate
- 6 ft Sea Level Rise - Extreme

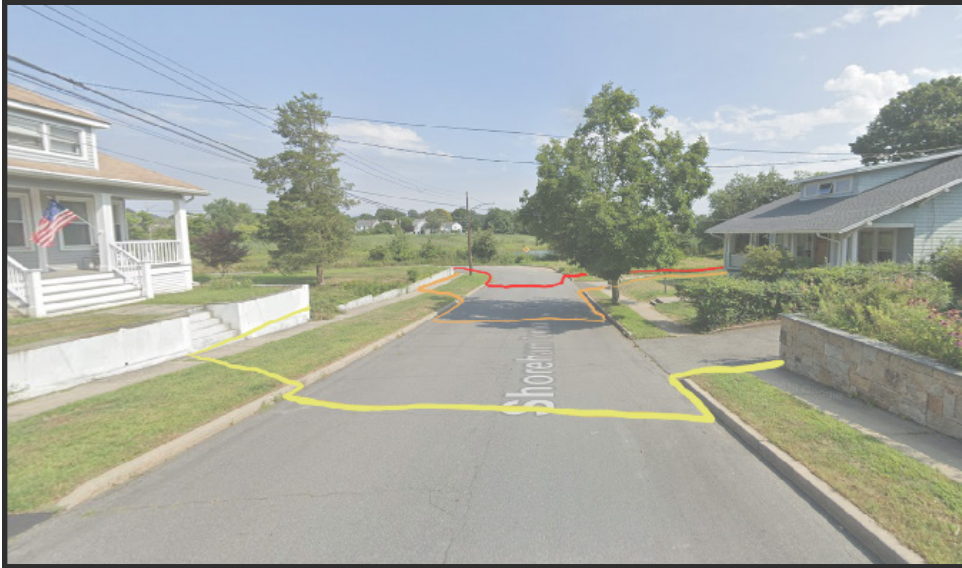
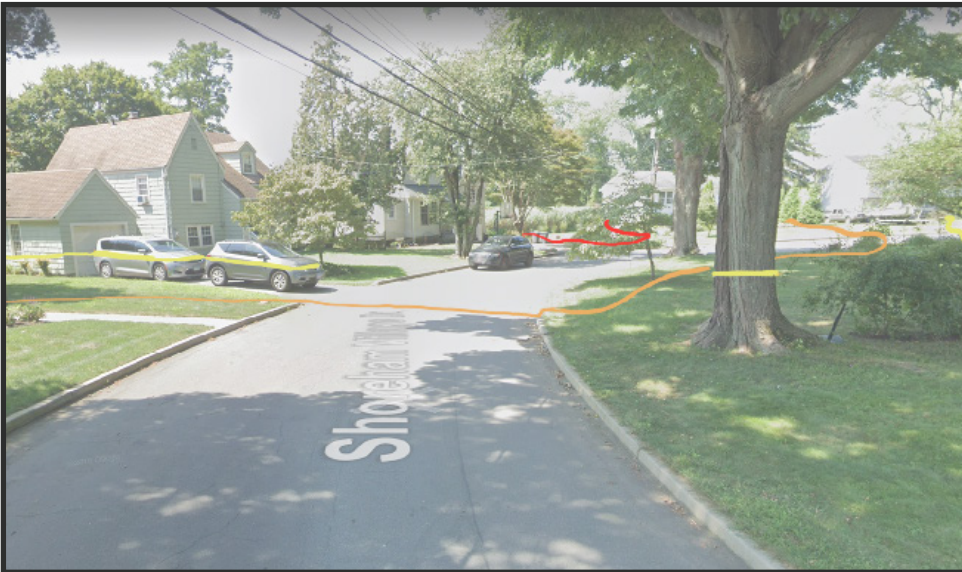
- 2 ft Sea Level Rise - Low
- 4 ft Sea Level Rise - Intermediate
- 6 ft Sea Level Rise - Extreme

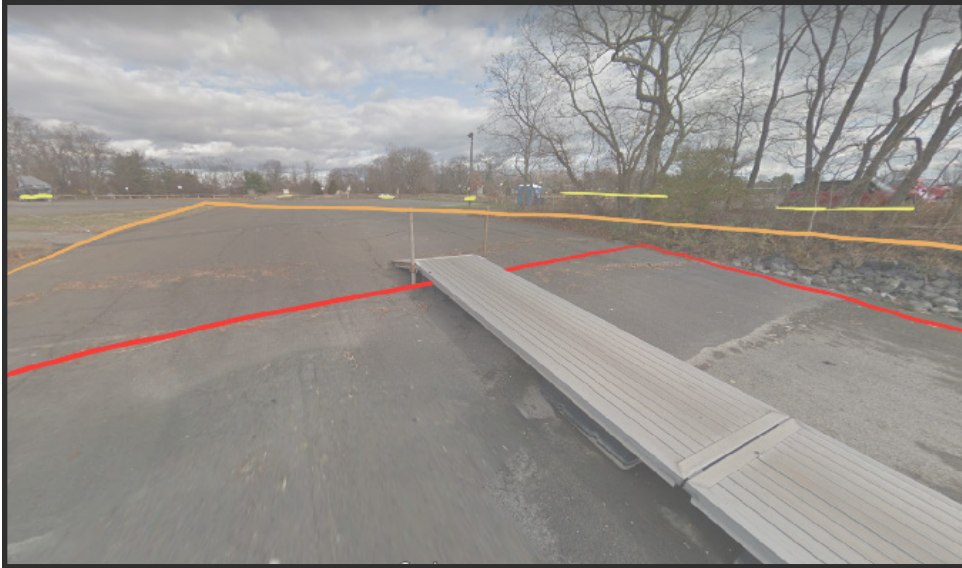
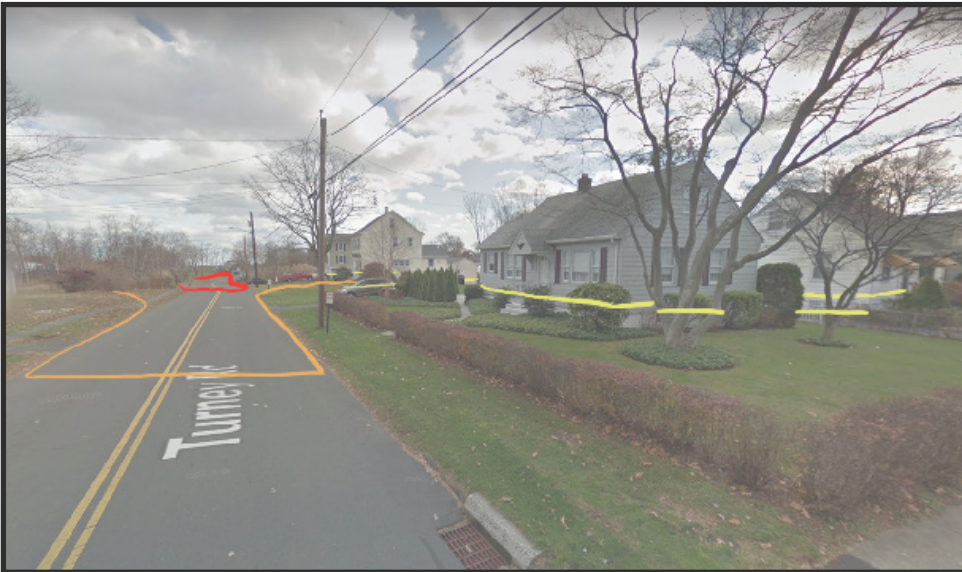
- 2 ft Sea Level Rise - Low
- 4 ft Sea Level Rise - Intermediate
- 6 ft Sea Level Rise - Extreme
